Pentium® II Processor Specification Update

Release Date: November 1998

Order Number: 243337-020

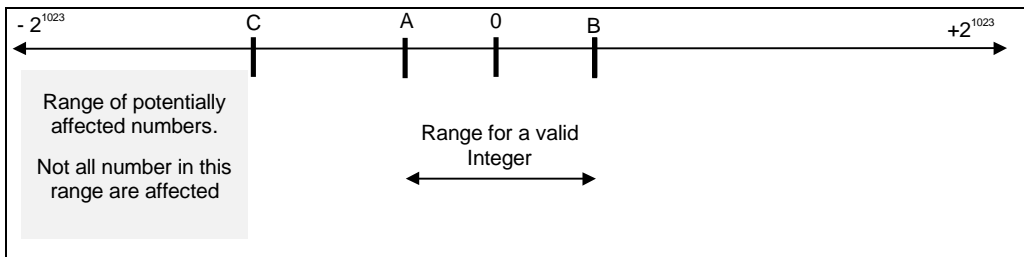
IMPLICATION: Erroneous operation results when the operand is so large that it will not fit into the target data size. The operands affected by this erratum are significantly outside (by a factor of 3X) the range that can be, correctly, converted to an integer value. The figure below and corresponding table identifies the normal range of integer numbers (between A and B) and the starting point of the operands affected by this erratum. Discrete failing operands will be present in the range between point C and the maximum negative number that can be represented by the processor (-2^{1023} in double precision format). Note 2 below gives a qualitative description of the nature of the discrete failing values. Software that does not rely on the Invalid Operation exception flag being set and signaled by either an exception OR by software polling is not impacted by this erratum.

16-bit Operation	A	B	C
	-32,768.0	+32,767.0	< -98304.0
32-bit Operation	A	B	C
	-2,147,483,648.0	+2,147,483,647.0	< -6,442,450,944.0

WORKAROUND: Any of two software workarounds will avoid occurrence of this erratum:

1. Range checking performed prior to execution of the FIST[P] instruction will prevent the overflow condition from occurring, and may already be implemented as a coding style.
2. Software can use the presence of MAXNEG in the result integer to indicate that an out of range conversion may have occurred.
